Report #75981221

PRACTICAL COMPLETION INSPECTION

THIS IS A VISUAL ONLY BUILDING INSPECTION & REPORT CARRIED OUT IN ACCORDANCE WITH AS4349.0

DEFECT DOCUMENT REPORT

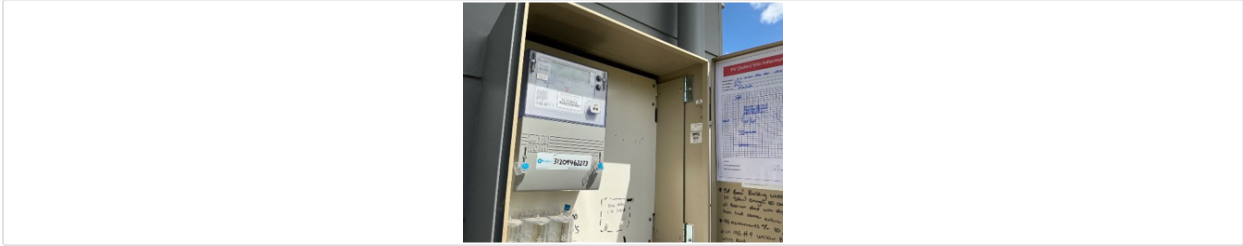
Type: Termite | Location: Meter box

- #1 – Termite notice is installed – ensure regular inspections with installing company annually or warranty will be voided

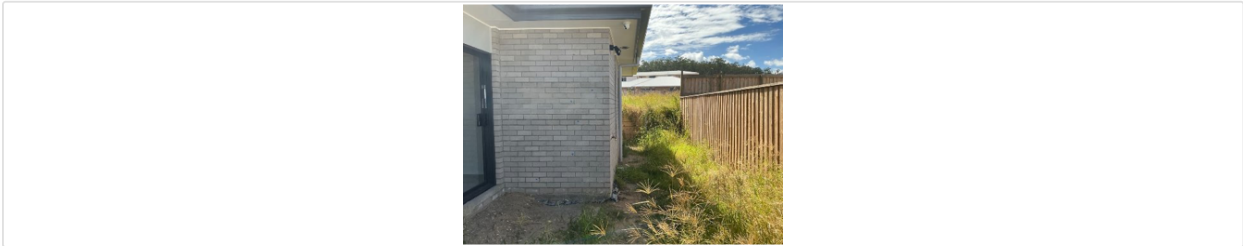
Type: Site Defects | Location: East Elevation

- #2 – Ground levels inadequate – surface water drainage can cause water to lay against footings – to be rectified as per BCA 3.1.2.3 and QBCC 2.3

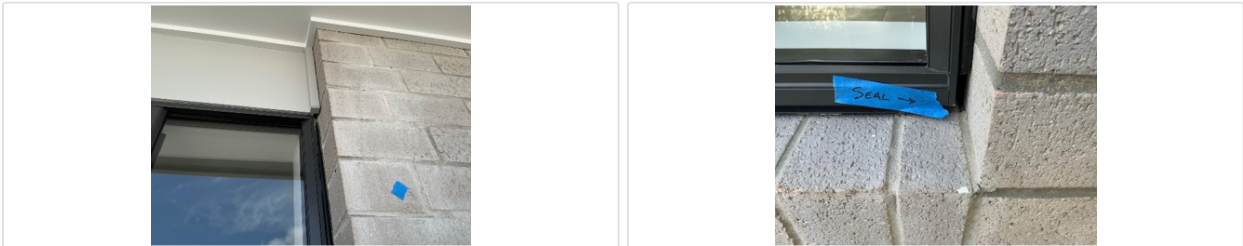
Type: Windows & Doors (External) | Location: West Elevation

- #4 – External door not fully weather sealed – allows water penetration in weather conditions anticipated by BCA – to be rectified per QBCC 9.2

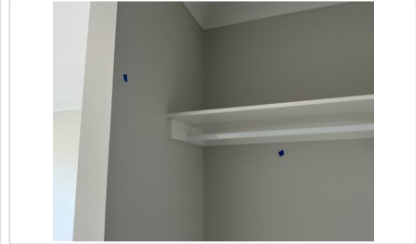
Type: Paint | Location: Though out marked with Blue tape

- **#5 – Paint touch-ups required – starved areas, patching/holes, pipes, meter box, man-hole – all to be completed as per QBCC 13.2**

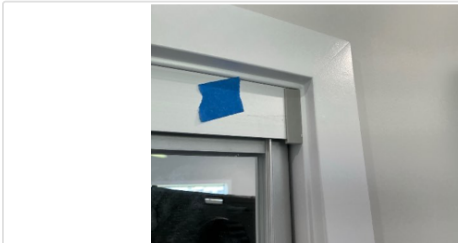
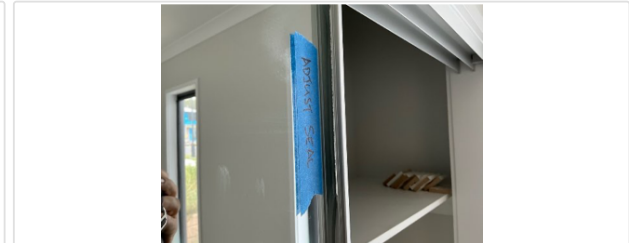
Type: Windows & Doors (Internal)

- **#7 – Internal glazing imperfections – scratches, chips – to be rectified per AS 4667**
